# **Southhampton Minicipal Complex**

## **Vacuum Excavation Report**

**Trinity Project #: 26-26558.002**  
**Inspection Date: 02 September 2026**

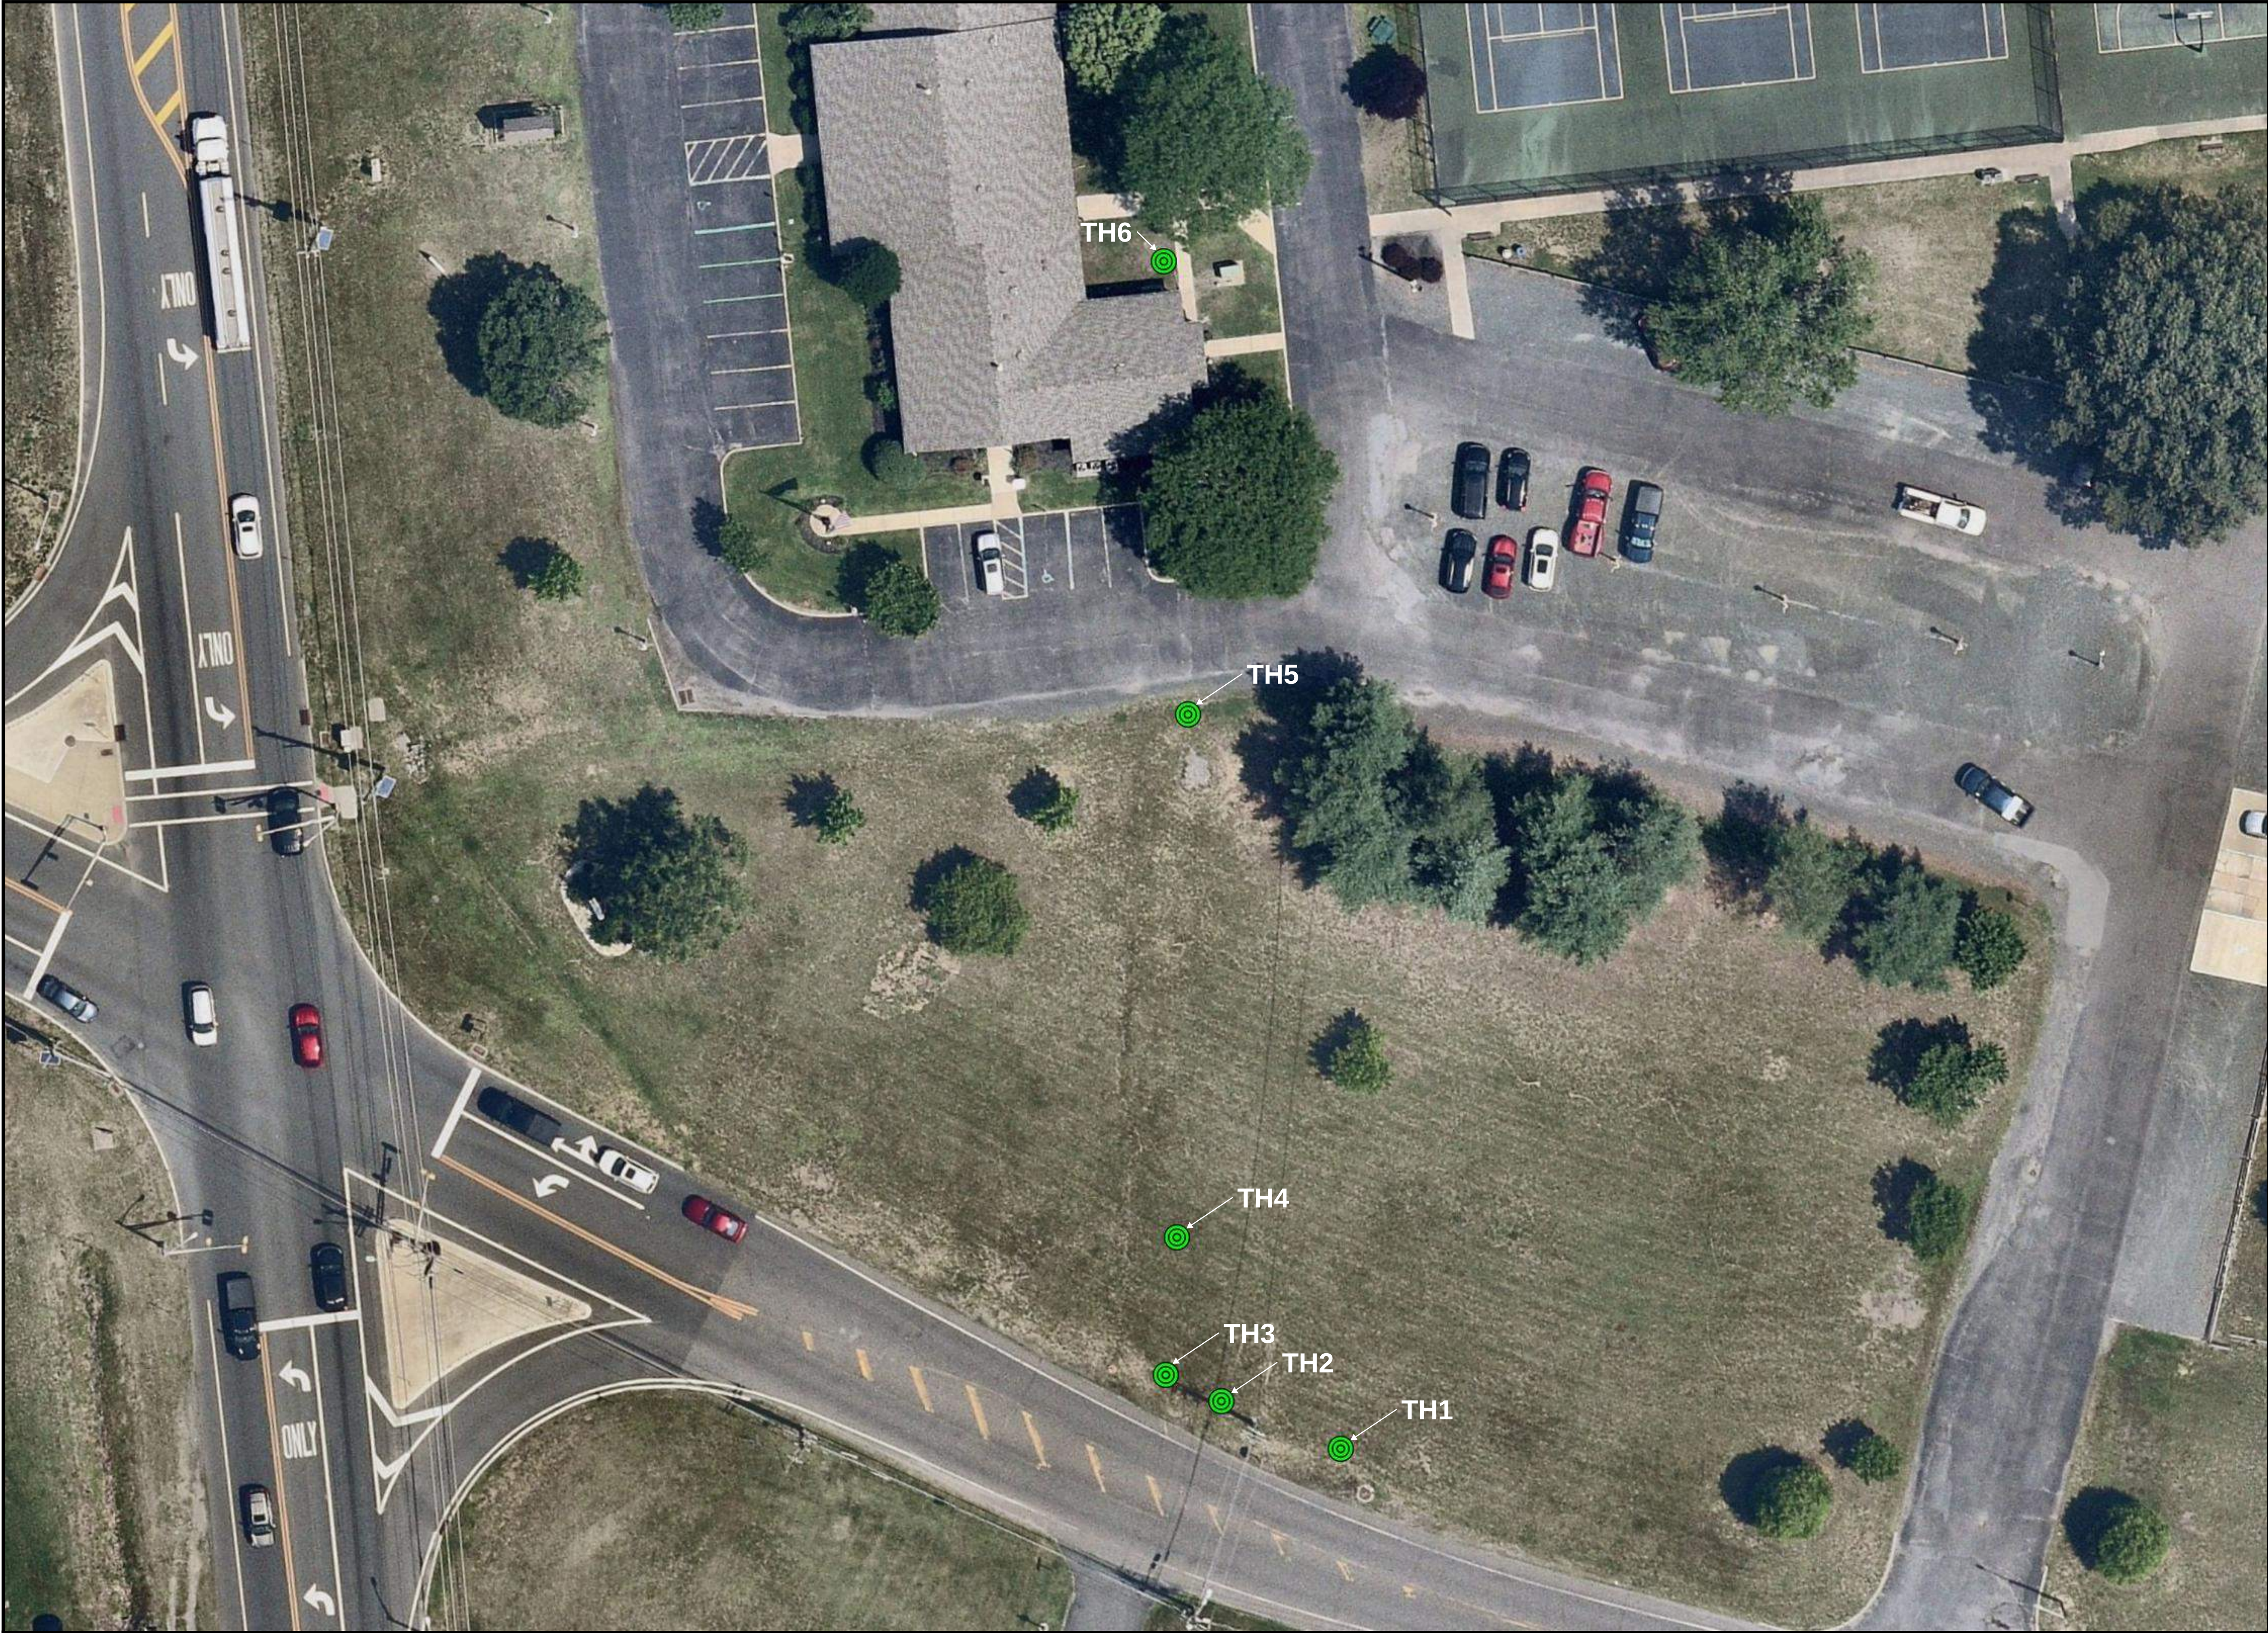
## TEST HOLE LOCATION SHEET

Test Hole Location

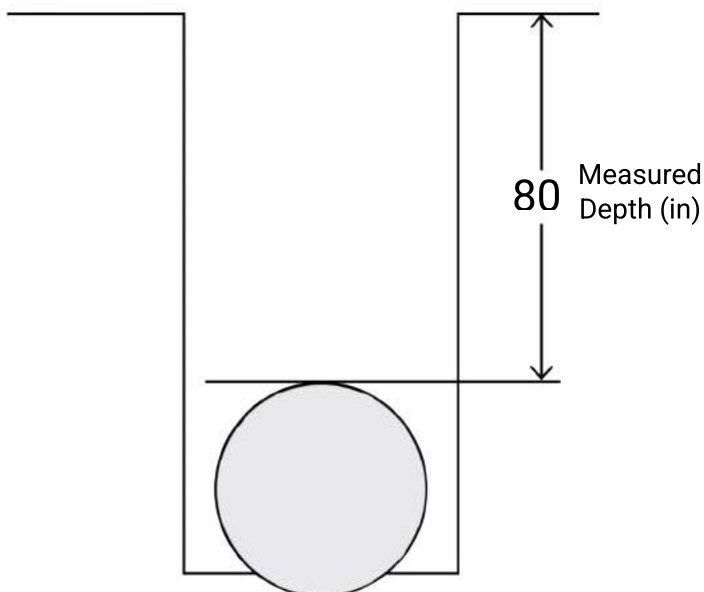
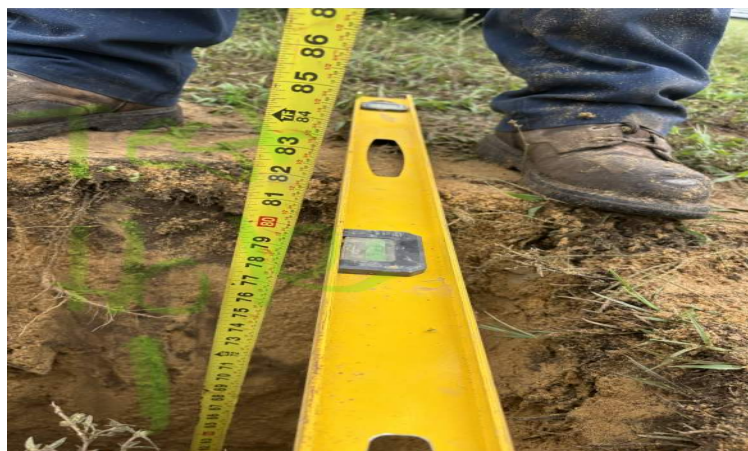
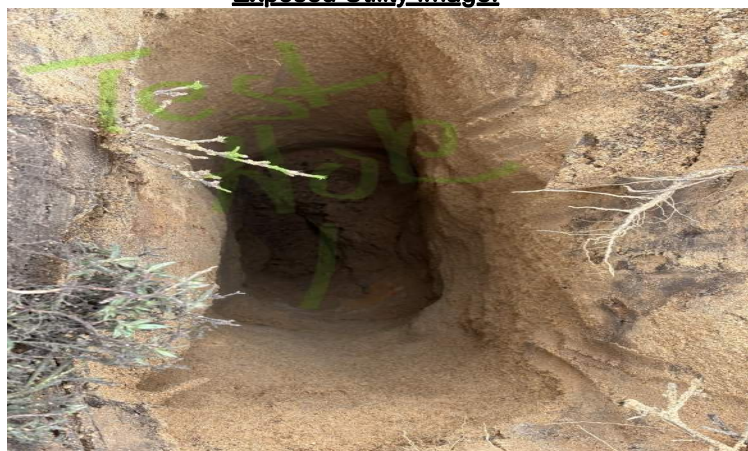
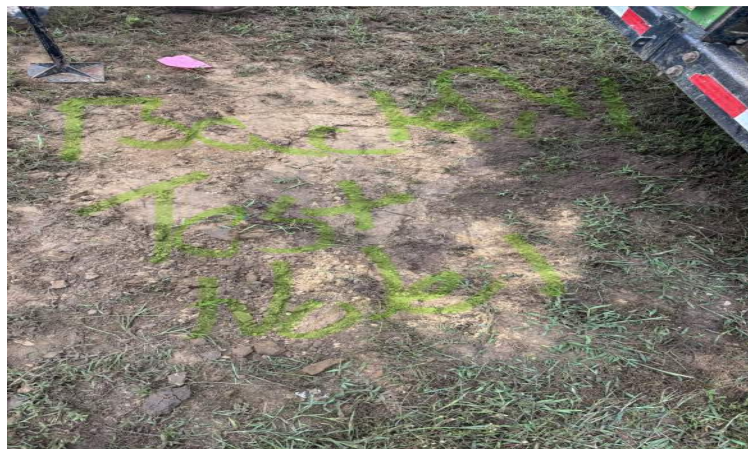
Test Hole Number: **TH1**

| Utility Found: | Sanitary Sewer | Marker Type: | Flag |
| Utility Depth (in): | 80 | Soil Type: | Sand |

No utility found

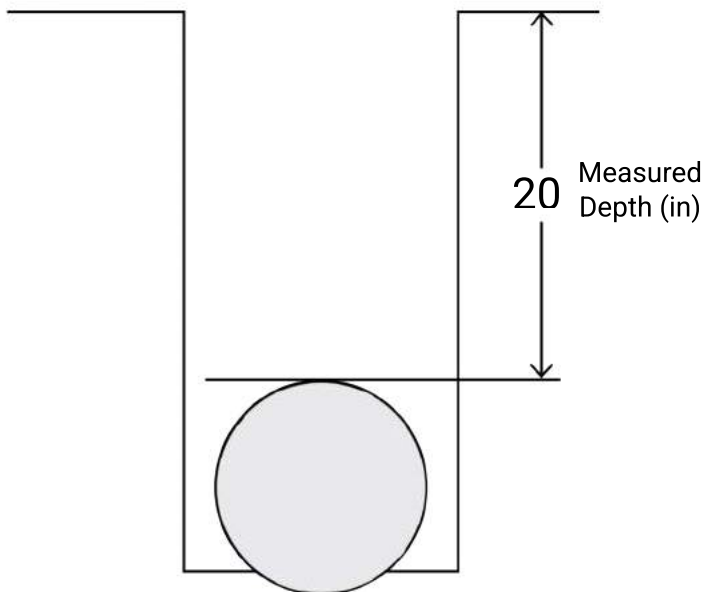
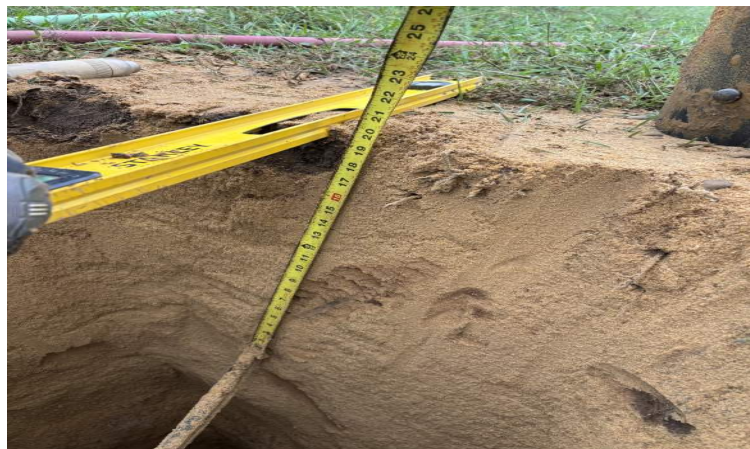
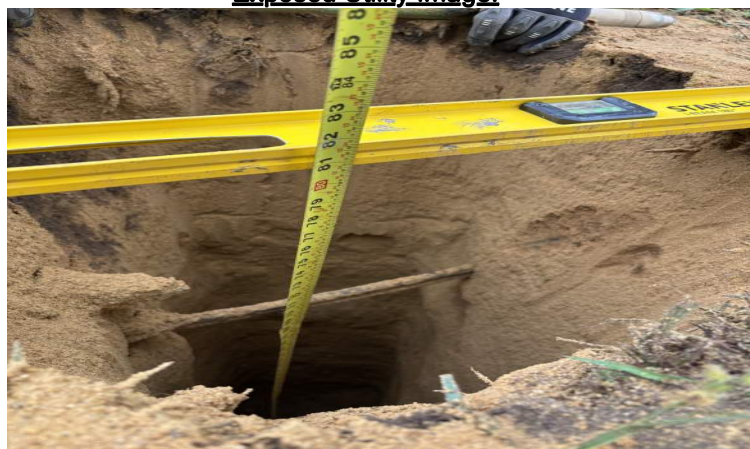
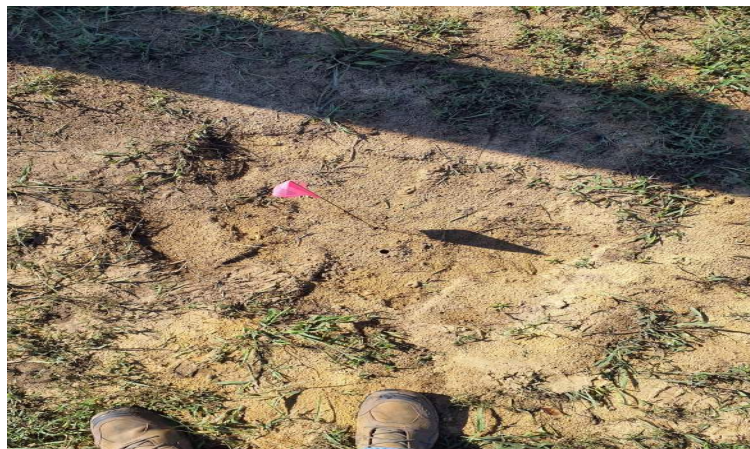
Test Hole Number: TH2

| Utility Found: | Communications | Marker Type: | Flag |
| Material Composition: | PVC | Marker Placement: | Center |
| Utility Size (in): | 1 | Pavement Type: | Grass |
| Utility Depth (in): | 20 | Soil Type: | Sand |

Were looking for sewer but found communication line instead

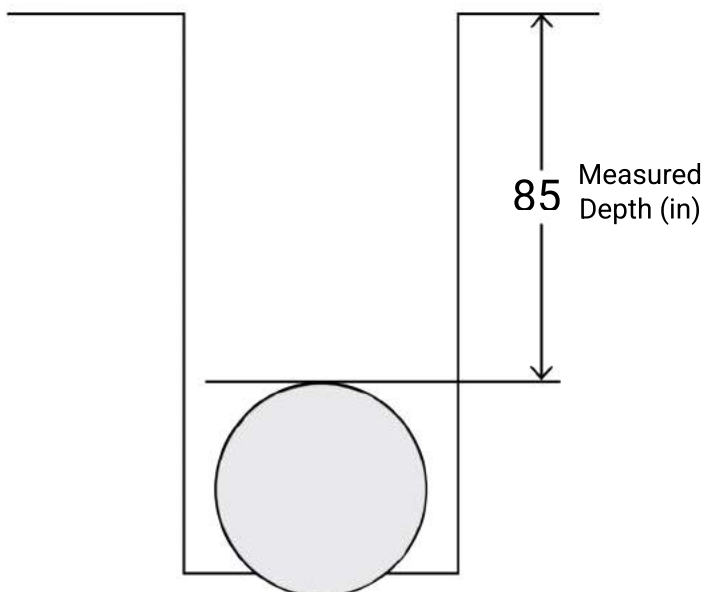
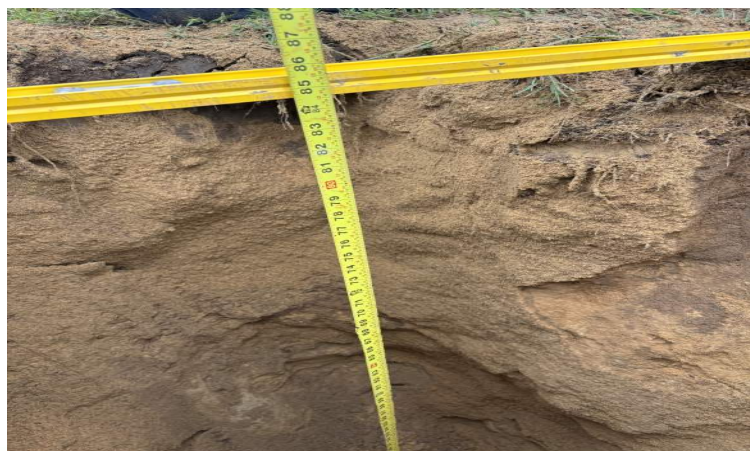
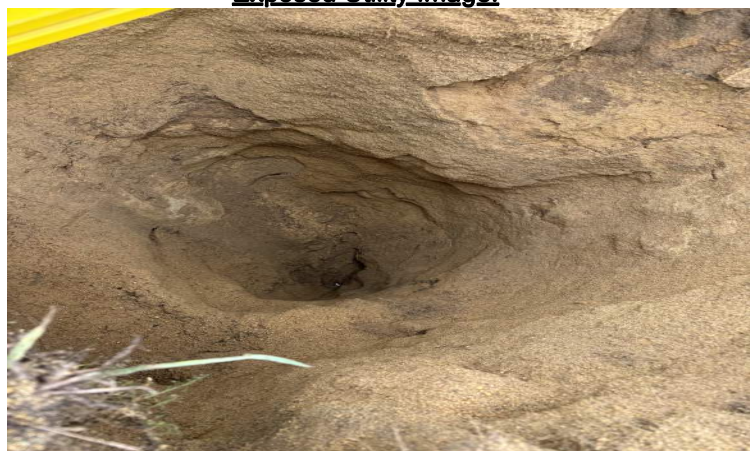
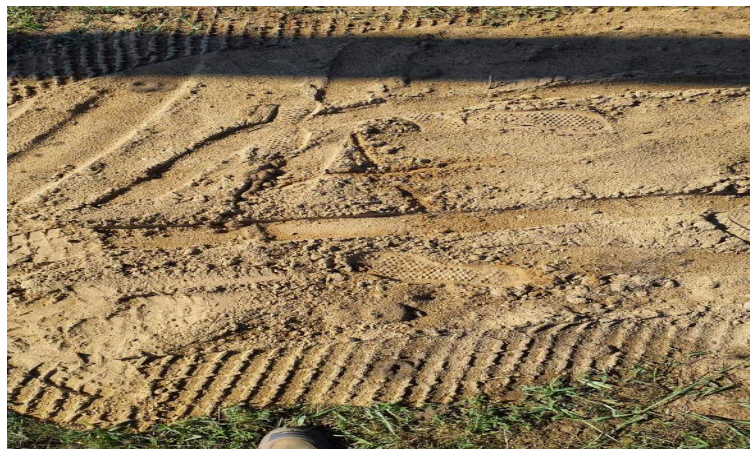
Test Hole Number: **TH3**

| Utility Found: | Unknown | Marker Type: | Flag |
| Utility Depth (in): | 85 | Soil Type: | Sand |

Nothing found

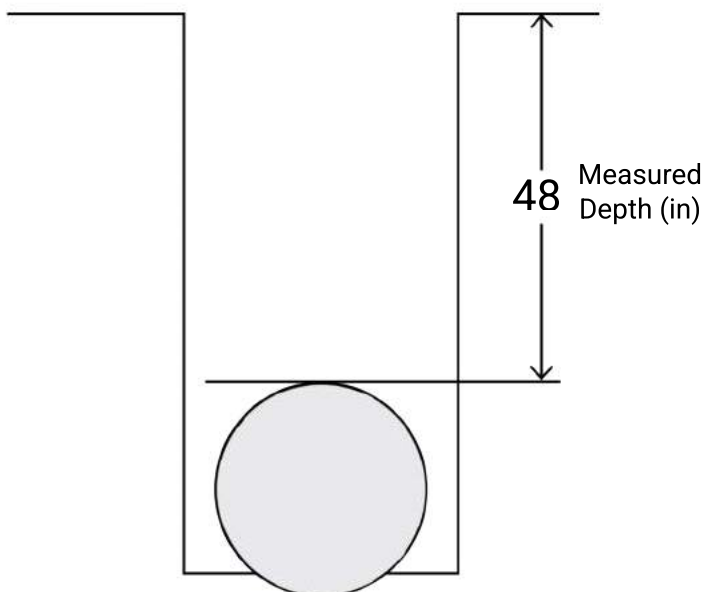
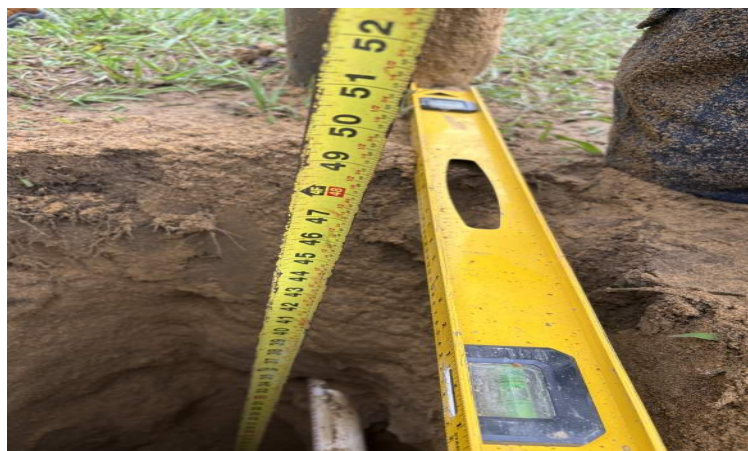
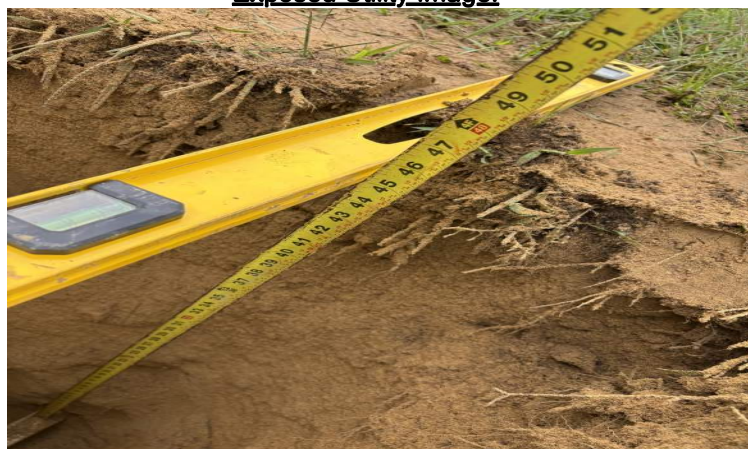
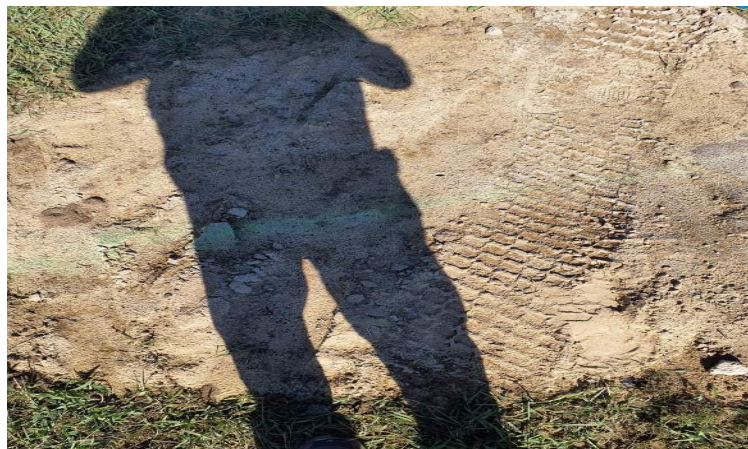
Test Hole Number: **TH4**

| Utility Found: | Sanitary Sewer | Marker Type: | Flag |
| Material Composition: | PVC | Marker Placement: | Center |
| Utility Size (in): | 1.5 | Pavement Type: | Grass |
| Utility Depth (in): | 48 | Soil Type: | Sand |

Sewer expo

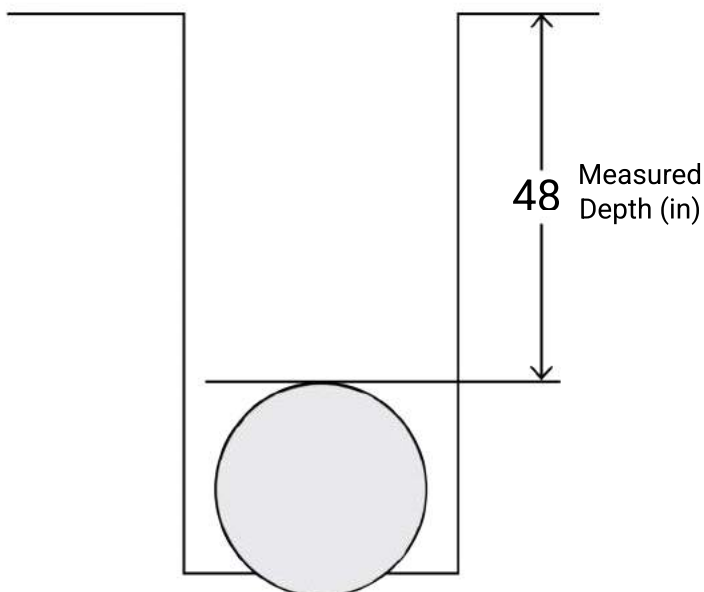
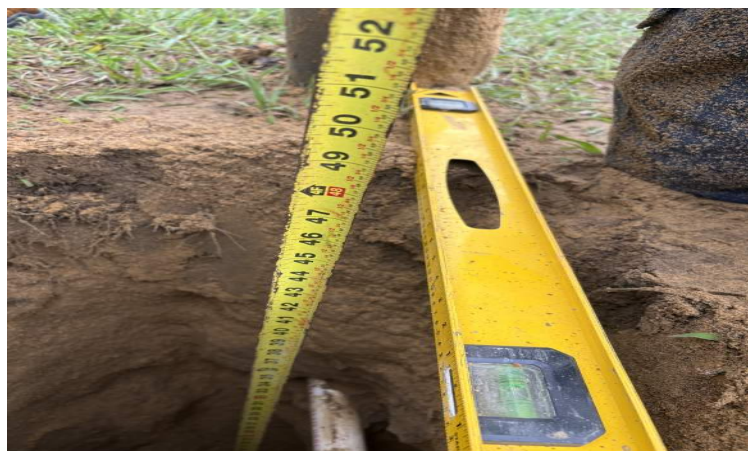
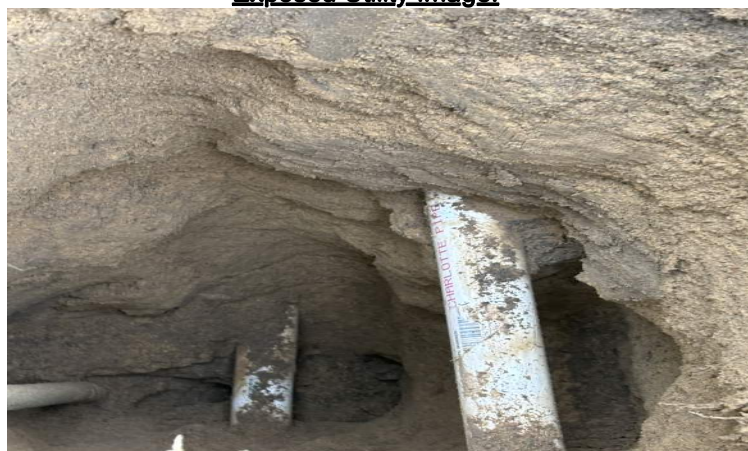
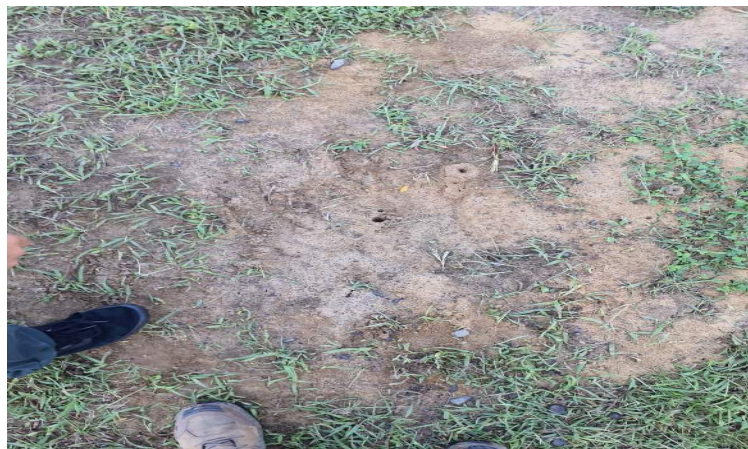
Test Hole Number: **TH5**

| Utility Found: | Sanitary Sewer | Marker Type: | Flag |
| Material Composition: | PVC | Marker Placement: | Center |
| Utility Size (in): | 1.5 | Pavement Type: | Grass |
| Utility Depth (in): | 48 | Soil Type: | Sand |

Exposed sump pump pipe as well along with sewer pipe

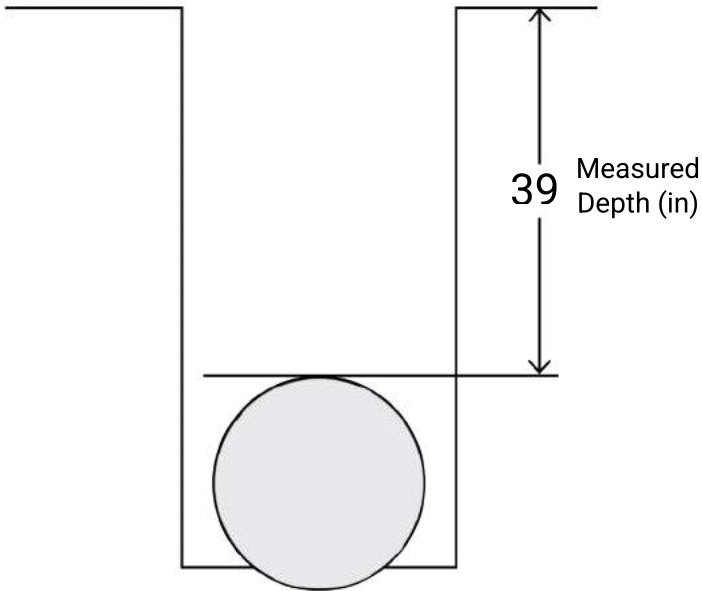
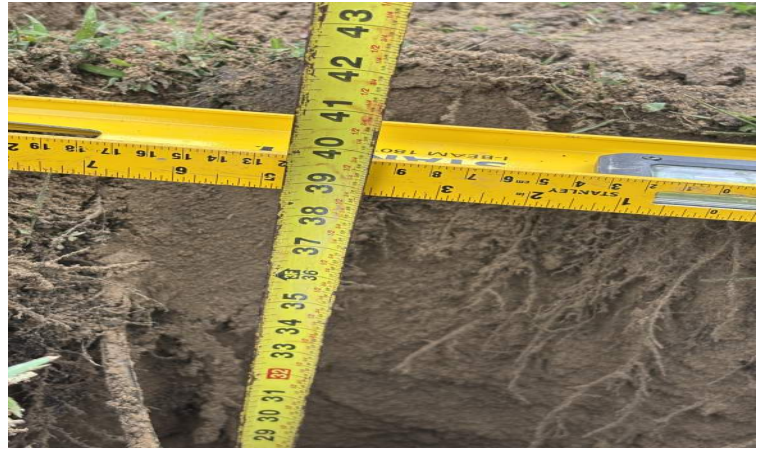
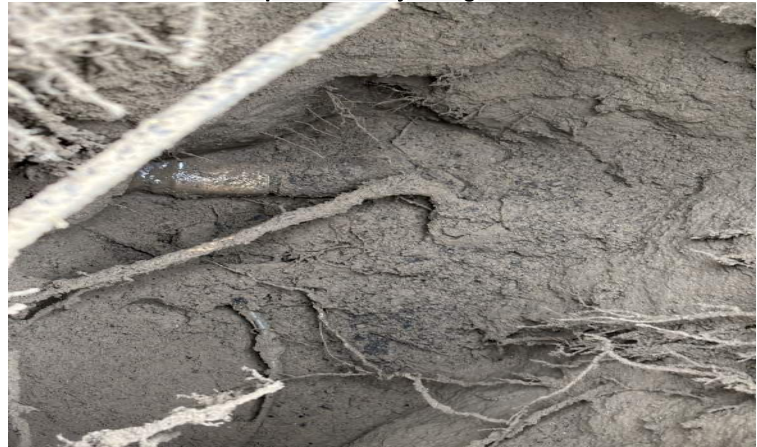
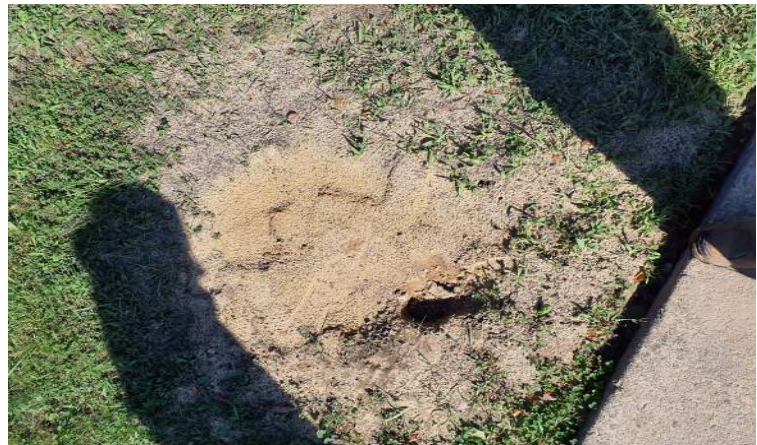
Test Hole Number: **TH6**

| Utility Found: | Sanitary Sewer | Marker Type: | N/A |
| Material Composition: | PVC | Marker Placement: | N/A |
| Utility Size (in): | 1.5 | Pavement Type: | Grass |
| Utility Depth (in): | 39 | Soil Type: | Sand |

Exposed sewer pipe by pump station.
